Radford Army Ammunition Plant

NEW RIVER UNIT (NRU)

History

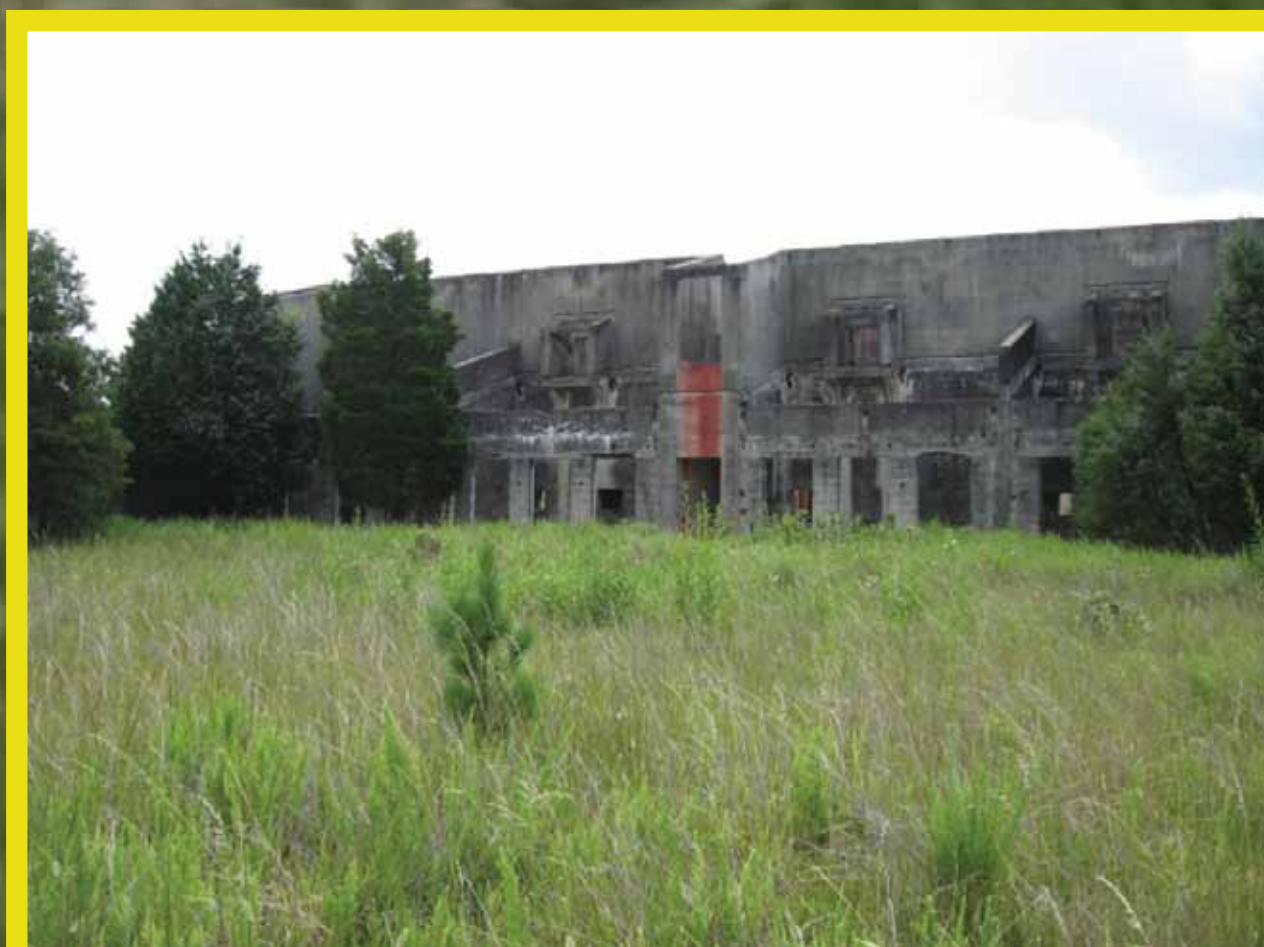
Bag Loading Area (BLA) and Igniter Assembly Area (IAA)

- Both sites were utilized during WWII to assemble and pack propellants. Active Operations ceased in 1945.
- Several buildings at each site contained a metallic conductive flooring material to prevent buildup of static charges. This flooring material was exposed to weathering when wooden roofs and walls were removed from the buildings. The flooring material has degraded due to weathering and has potentially leached metals to the soils surrounding the buildings.

- Approximately 44,000 ft² of the flooring material has been identified within the buildings at the BLA and the IAA.
- Soil is primarily affected by lead, copper and asbestos detected above industrial screening levels. Generally limited to soils immediately adjacent to buildings with conductive flooring.

- IAA: Remedial Actions being considered include removal and/or capping of conductive flooring and addressing soils containing asbestos at levels greater than remedial action levels.

- BLA: Remedial Actions recommended include removal of conductive flooring and removal of soils containing asbestos, lead and copper at levels greater than remedial action levels to achieve military/industrial future land use at the BLA and residential land use at the IAA.

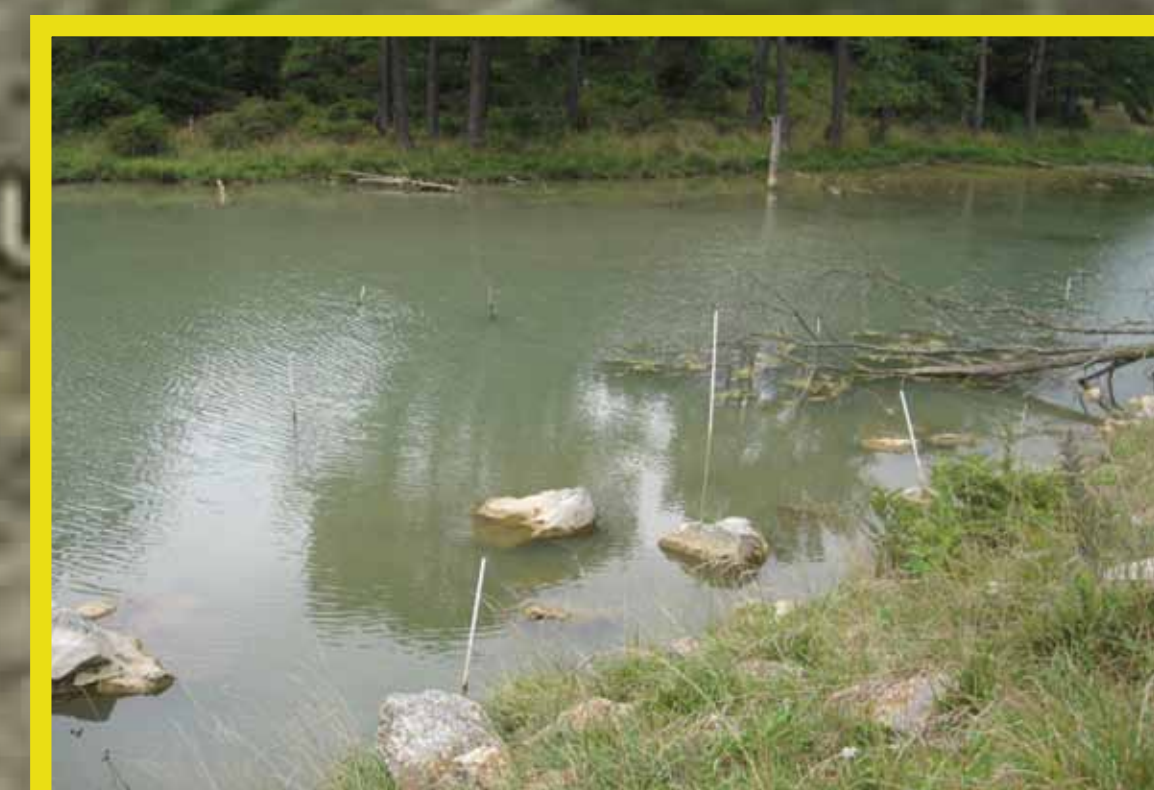
Western Burning Ground (WBG) and Northern Burning Ground (NBG)

- The two burning grounds were used to decontaminate explosives contaminated materials and to dispose of off-spec energetics.
- **WBG**
 - A test pitting investigation was completed at the WBG in 1999 that effectively removed soils above residential screening levels in the source area.

- Lead was detected in an ashy layer of material beneath the road within the WBG at concentrations greater than the residential screening level.
 - Arsenic, lead, chromium and iron were detected in pond sediments at concentrations greater than industrial screening levels.

- Various PAHs were detected at concentrations greater than industrial screening levels in stream sediments downgradient of the pond and in soil within the site drainage ditch.

- Remedial Action recommended is land-use controls under current land use (i.e., military/industrial).
- **NBG**
 - Lead and chromium have been identified as the primary constituents of concern at the site.

- Removal Action started in 2009 to achieve residential land use.
